PRESIDENCY of CIVIL AVIATION

AIRCRAFT ACCIDENT REPORT

Saudi Arabian Airlines

Lockheed L-1011, HZ-AHK

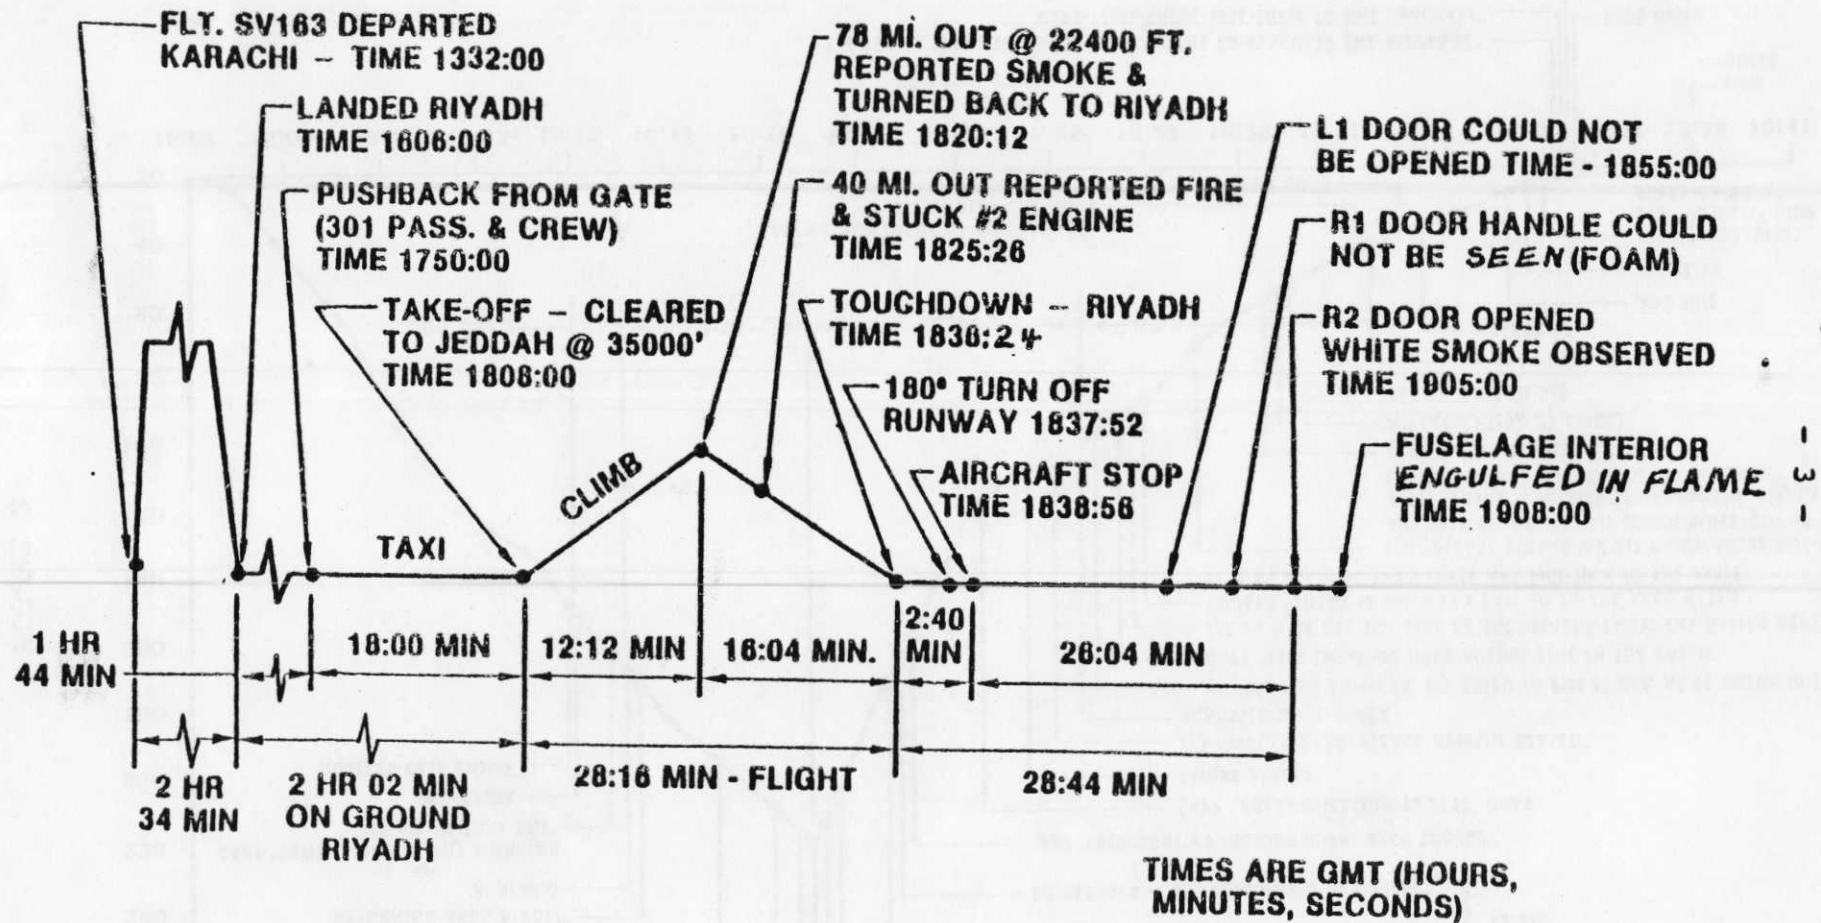
FIGURE 1

A total of 4 minutes and 21 seconds was spent by the flight crew in confirming the warning and when it became clear that a valid warning existed, the Captain elected to return to Riyadh. The Flight Engineer (F/E) had gone into the passenger cabin to investigate the situation and on returning to the cockpit, about thirty six seconds later, at about 1820:16, he informed the Captain that there was a fire in the cabin (see Appendix D - Cockpit Voice Recorder and Figures 1 and 2).

SV163 (S/N 1169) flight profile.

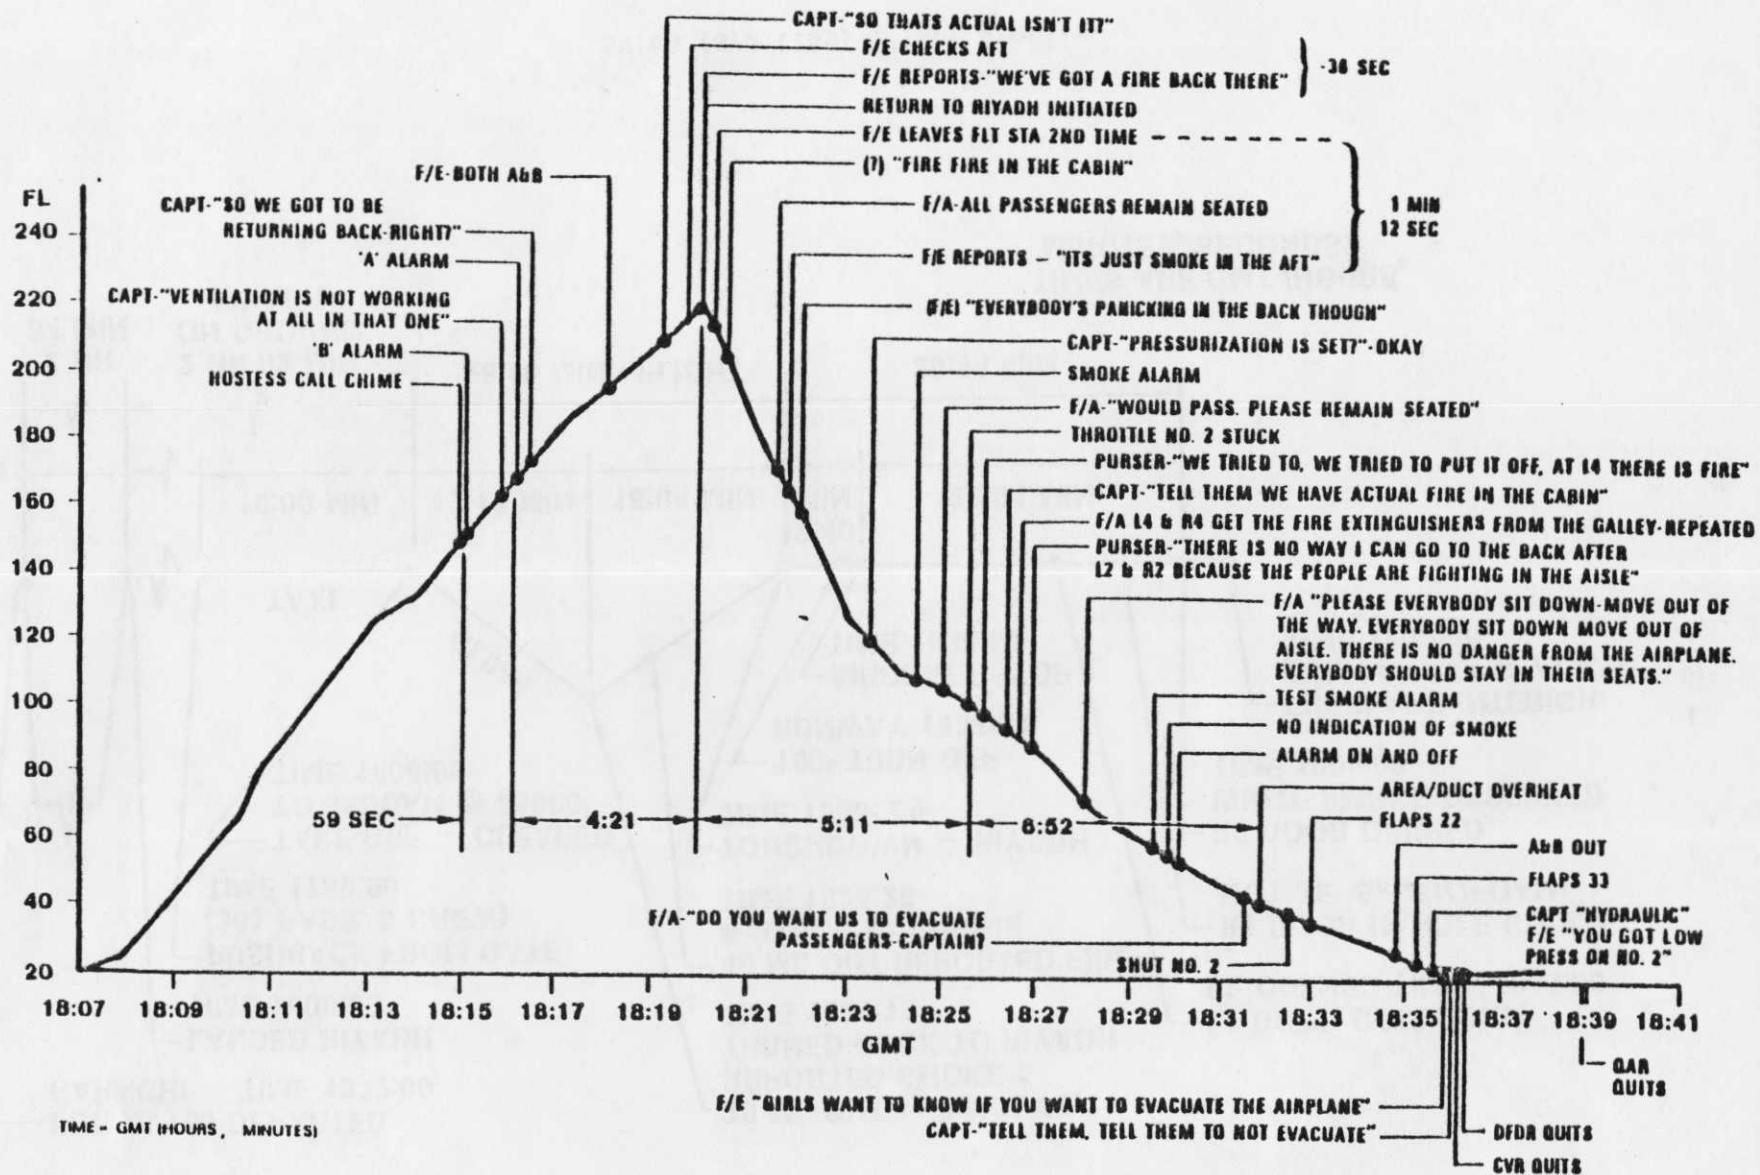
FIGURE 2

Figure 2
Flight profile and sequence of events.

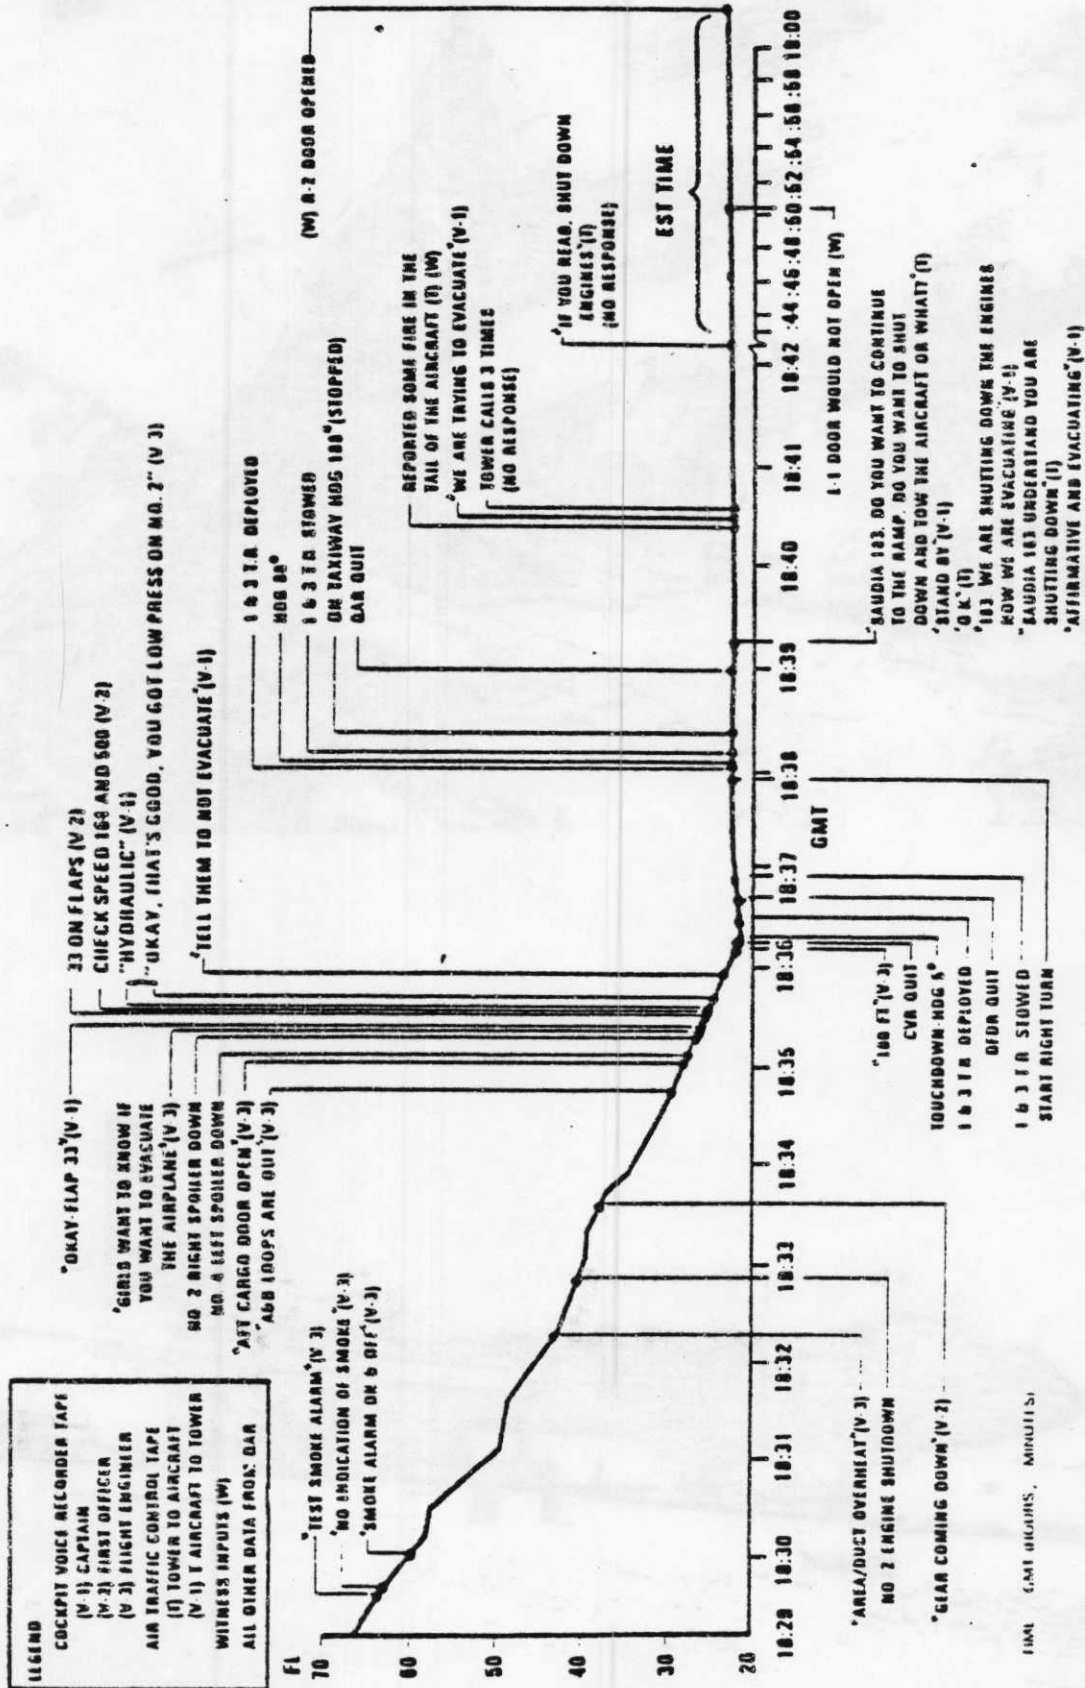
FIGURE 3

Attempts by the crash, fire, rescue personnel (CFR) to enter the aircraft and open the doors were unsuccessful until the No. 2 door on the right side of the aircraft was opened at about 1905, about 23 minutes after all engines had been shut down. At 1908, the fuselage interior was observed to be engulfed in flame. (see Figures 1, 2, and 3)

Sequence of events during approach to Riyadh and after landing.

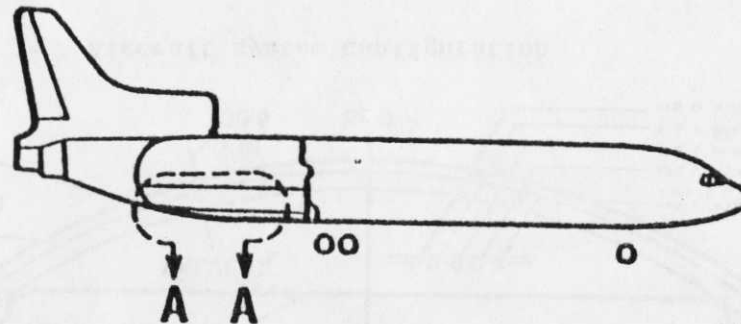
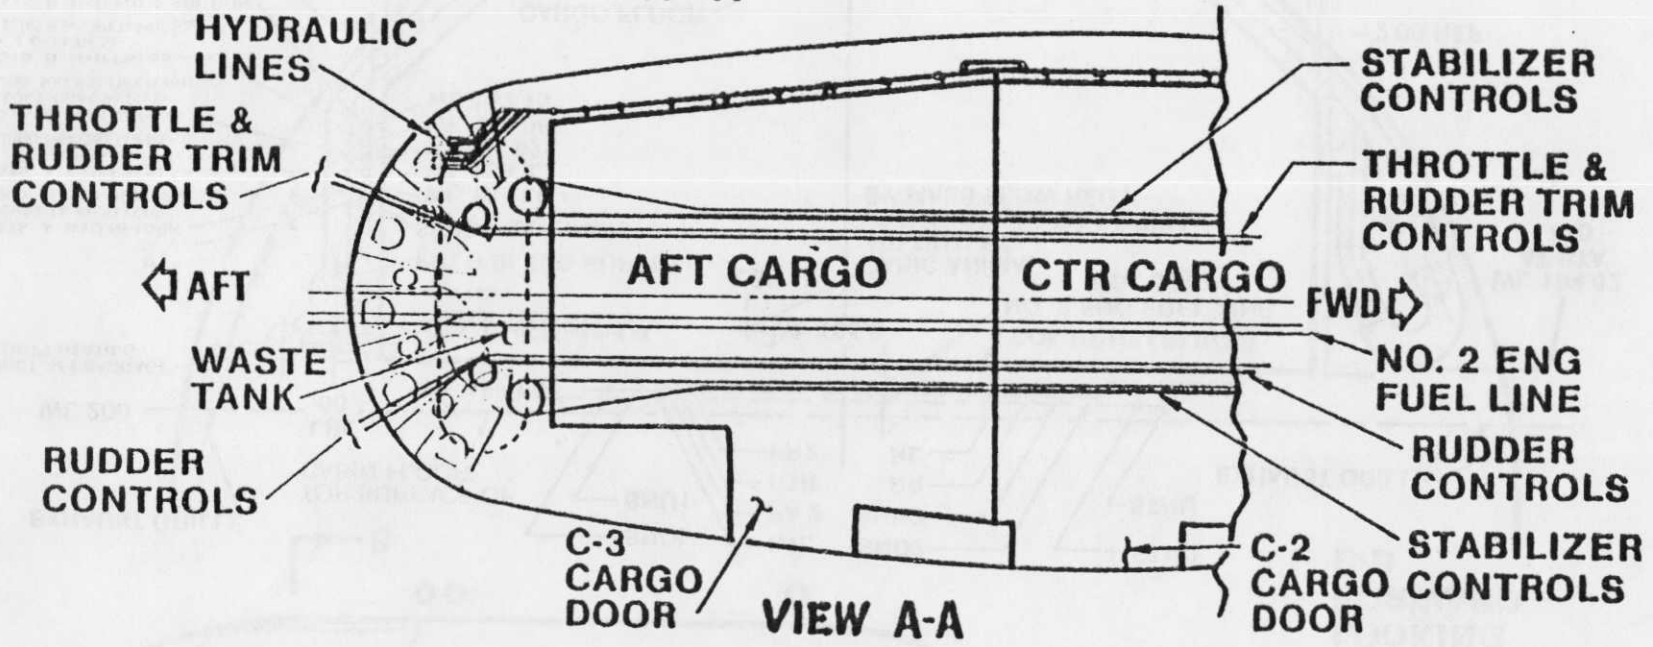
FIGURE 9

The main landing gear brakes were observed to be "off" approximately 10 hours after the accident. In order to determine why the brake pressure had bled off, the System "B" brake return line shut-off module, for parking brakes, was removed for testing. The module tested satisfactorily. The brake shuttle valves were removed and found to be in the "B" System position. When the shuttle valves were removed, some hydraulic fluid was in evidence. The reason the brakes were not in the "ON" position, although the parking brake lever was set, was not determined. For further details, see Figures 7, 8, and 9.

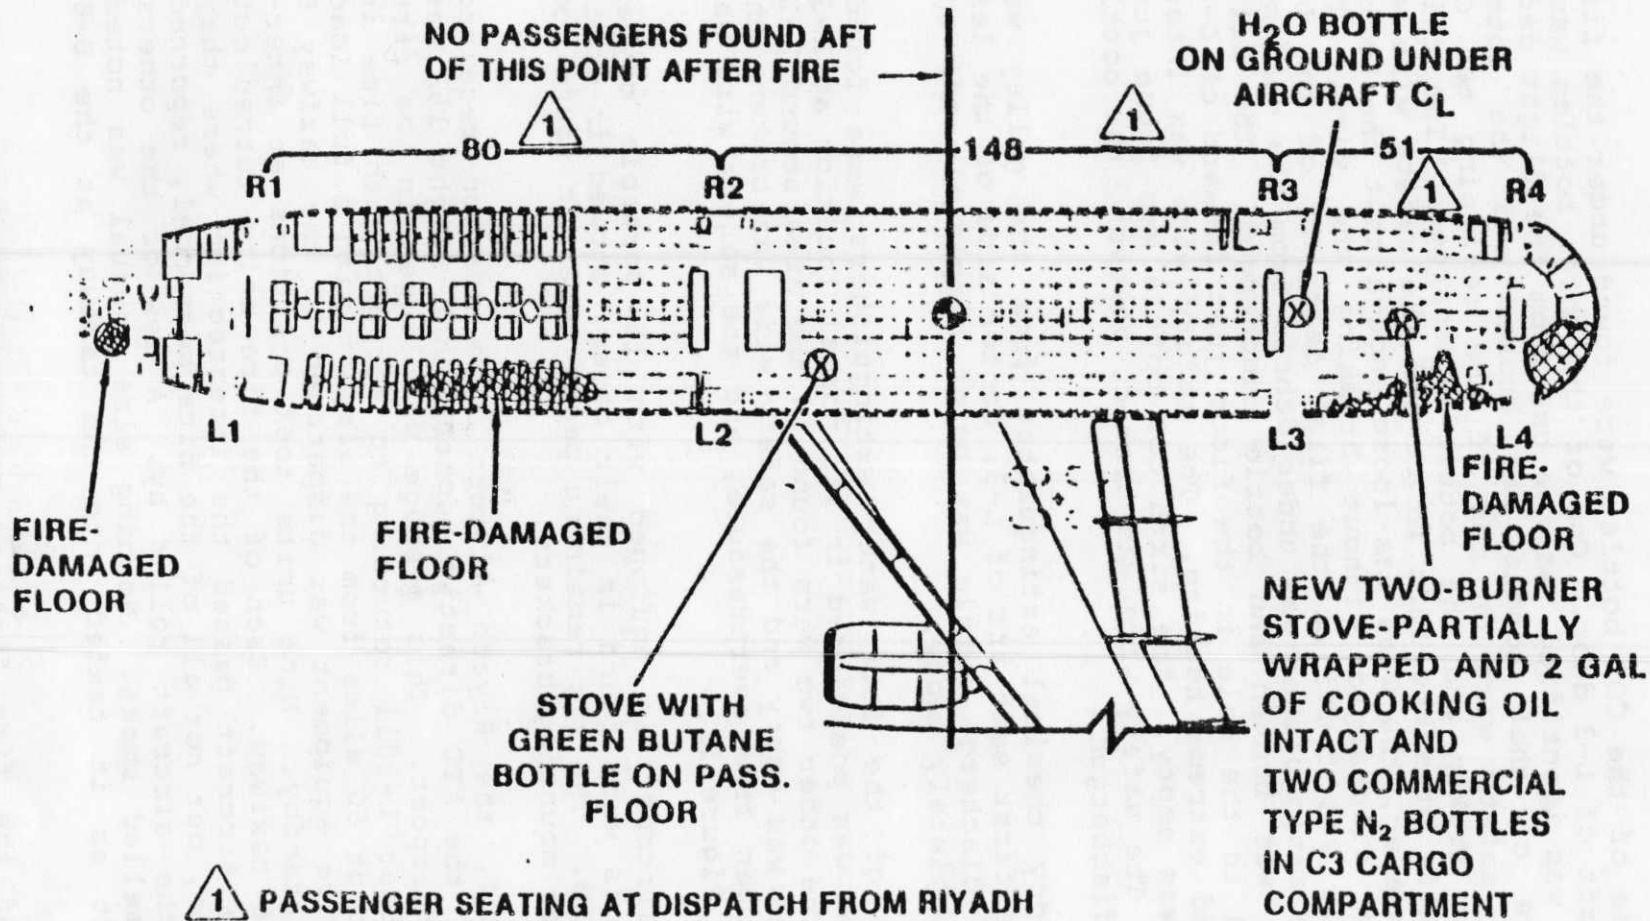
FIGURE 10

Most of the bodies in the cabin were located forward of L2 and R2 doors (see Figure 10).

Passenger placement, fuselage fire damage (floor) and significant articles.

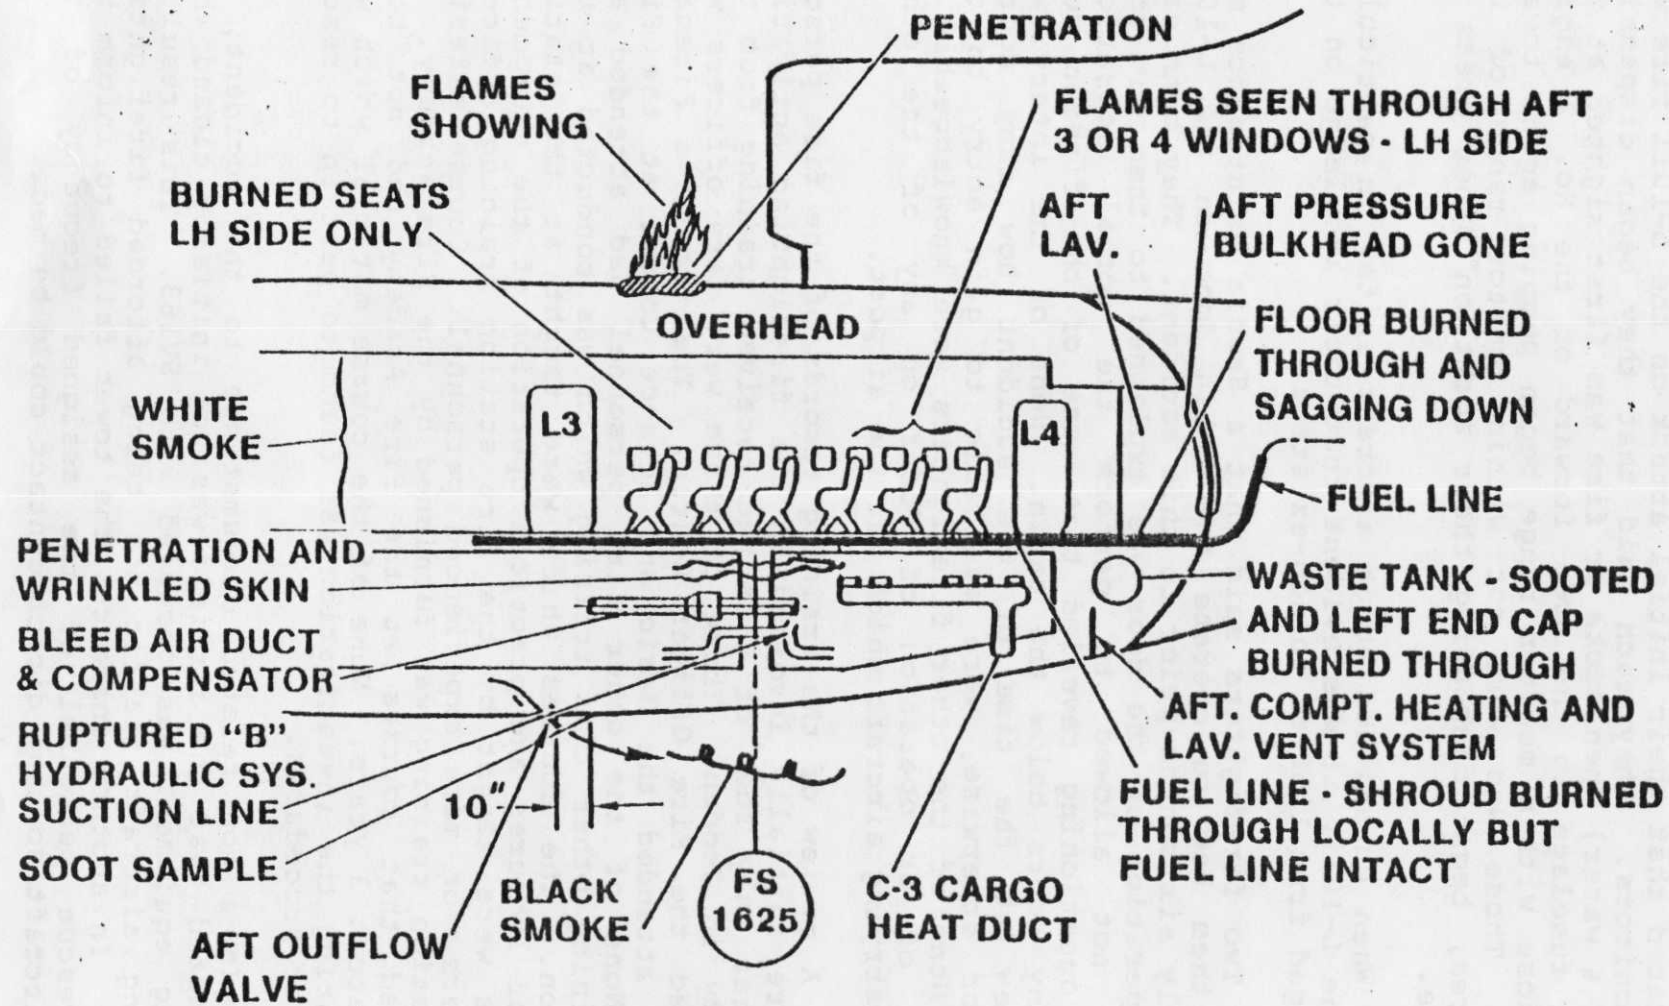
Aft fuselage conditions witnessed on ground.

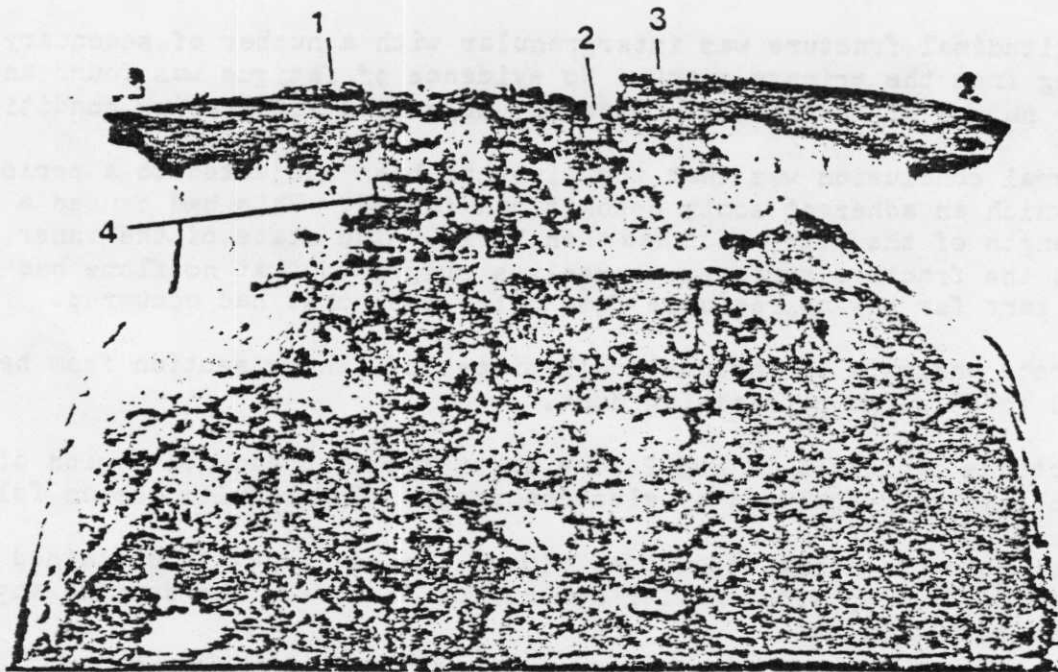
Fig 1

The piece of pipe in question is illustrated in Fig 1. It can be seen that the pipe
had split longitudinally, adjacent to a fabricated bend, and the split was followed
by outward peeling of the wall. The initial split was approximately 1.5 in long.

Hydraulic Pipe
